# ASSESSMENT OF THE IMPACT OF COMPREHENSIVE THERMAL MODERNISATION ON THE ENERGY EFFICIENCY OF A HISTORIC BUILDING: A CASE STUDY OF A HOUSE IN LOWER SILESIA, POLAND

Łukasz Czemarmazowicz, Aleksandra Nowysz✉

Institute of Civil Engineering, Warsaw University of Life Sciences – SGGW, Warsaw, Poland

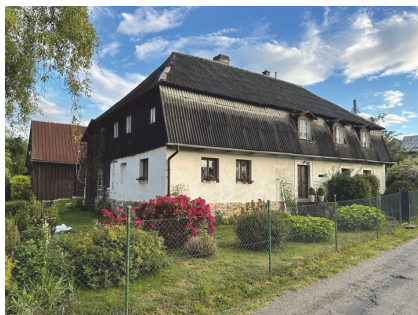
**Fig. 3.** Current state, north-east corner

The structure is a single-family residential building with an adjoining utility section. It comprises two usable storeys, an attic, and a partially underground basement located in the northwestern part. The foundation is primarily made of sandstone set in lime mortar. The ground-floor walls are built of brick, with the exception of the southwestern corner, which is constructed from timber logs. The upper storey is built using a half-timbered (or Prussian wall) technique, consisting of a wooden frame filled with a clay-and-chaff mixture. The attic spans the full area above the upper floor. The roof is a mansard type with gablets and three dormer windows on the northern side. It is currently covered with asbestos-cement sheets, though the original roofing material was wooden shingles. The ceilings are timber-framed and plastered from below with clay-based plaster applied on reed matting. The exterior façade is white, featuring lime plaster mixed with slag aggregate in a roughcast finish known locally as *baranek*. The main entrance consists of a double-leaf wooden door framed by a sandstone portal. The windows are traditional wooden box-type (Figs 3–7).

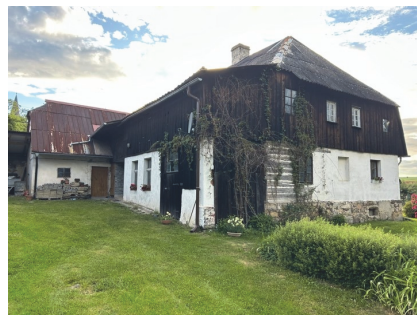
**Fig. 4.** Current state, south-east corner

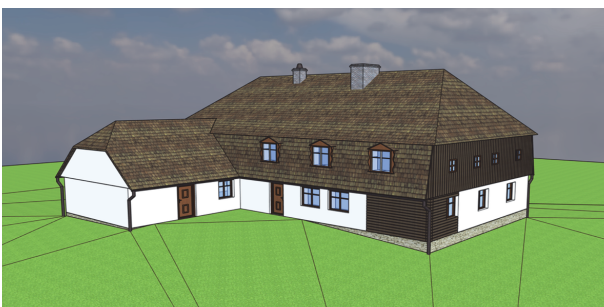
**Fig. 9.** 3D model of the building created in SketchUp, south-east corner

- Reconstruction of the original roof shape (Figs 8–9) and replacement of asbestos-cement sheets with historically appropriate roofing materials (e.g. wooden shingles or slate).
