THE IMPACT OF TRANSFORMATIONS OF THE SPACE OF TENEMENT HOUSES ON THE ARCHITECTURAL FORM OF THE BUILDING

ABSTRACT

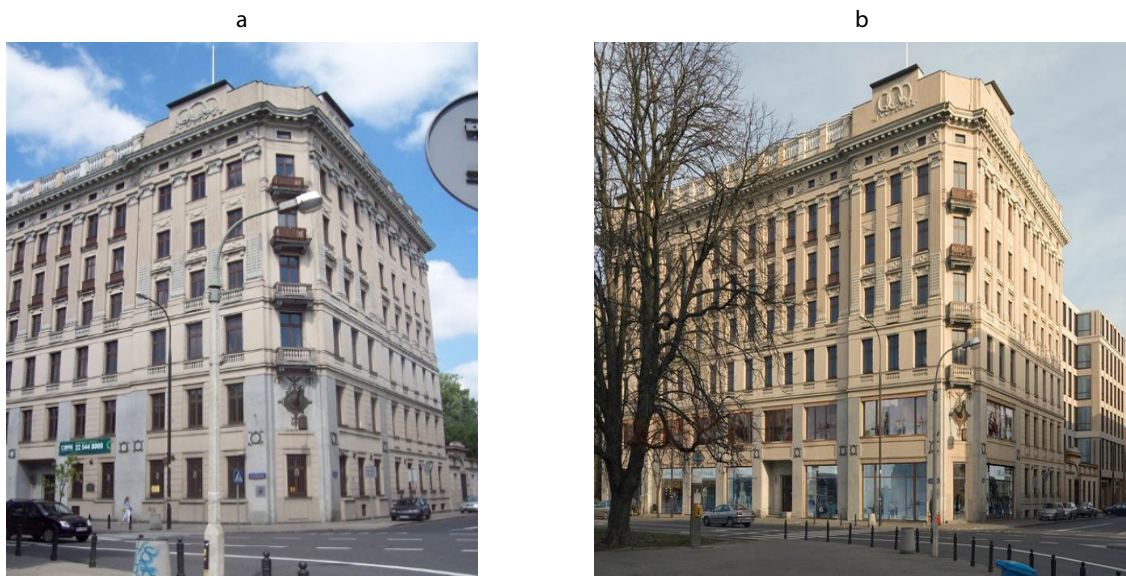
Fig. 1. Tenement house at Małachowskiego Square in Warsaw – the state before (a) and after renovation, which included shop windows installation on the 1st floor (b)

formations were already carried out in the interwar period, in the 1930s (Ginwiłł-Piotrowski, 1931; Minorowski, 1970), and they intensified in the 1980s and 1990s due to the development of private business. Changing the function of the ground floor from residential to service allows for the intensification of the street's public life by attracting new users to its space. In particularly attractive locations, the service function (commercial spaces) is also introduced on the 1st floor (Fig. 1).

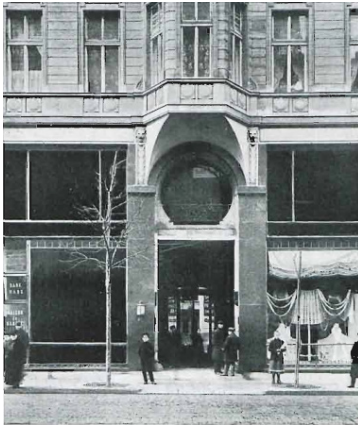
Fig. 2. The ground floor of a tenement house at Marszałkowska 137 (architect Dawid Lande) and the interior of the shop
Source: *Przegląd Techniczny* (1906), 44 (1), (tabl. XIX).

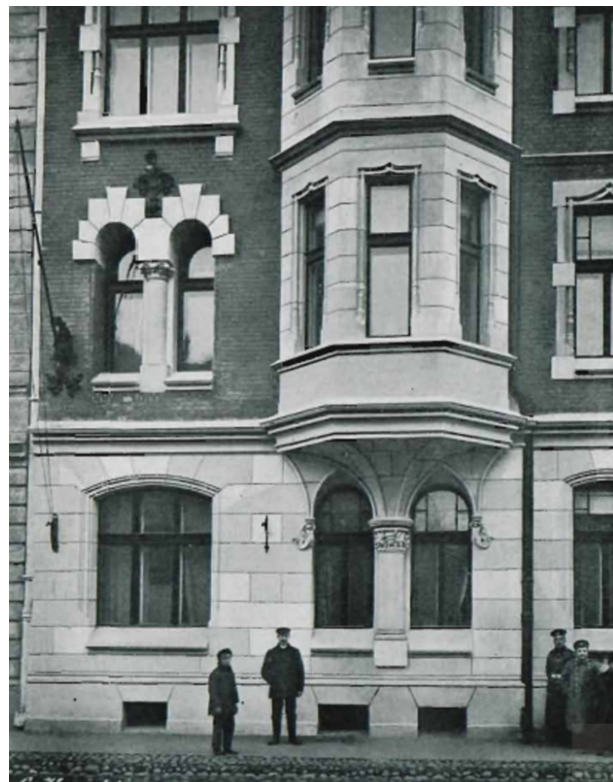
Fig. 3. The ground floor of a tenement house at Nowowiejska 19 in Warsaw (architect Stefan Szyller) – ground floor with a residential function

up, and residential premises were introduced in place of service premises. The new elements of the façade in the ground floor zone created in this way may differ in style from the character of the original façade. When re-adapting these premises, it will be necessary to design new façade solutions on the ground floor. The introduction of new elements on the façade will also be necessary if there was originally a dwelling on the ground floor (Fig. 3).

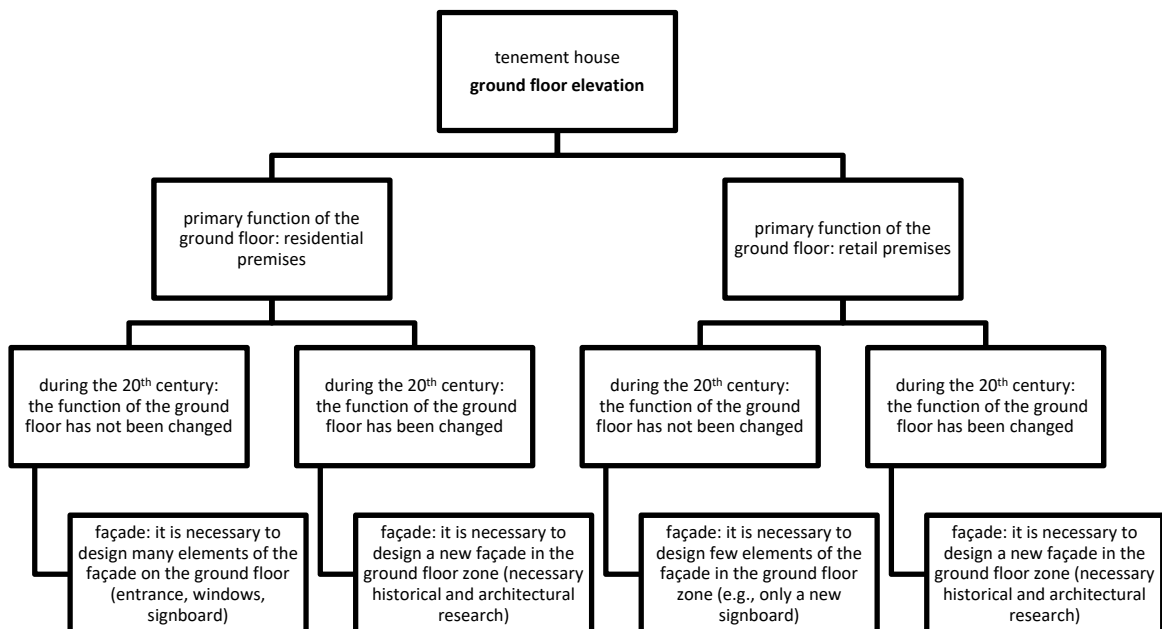
Fig. 4. Scheme of building transformations – ground floor of a tenement house

The described conditions and the necessary transformations resulting from them can be simplified in Figure 4.

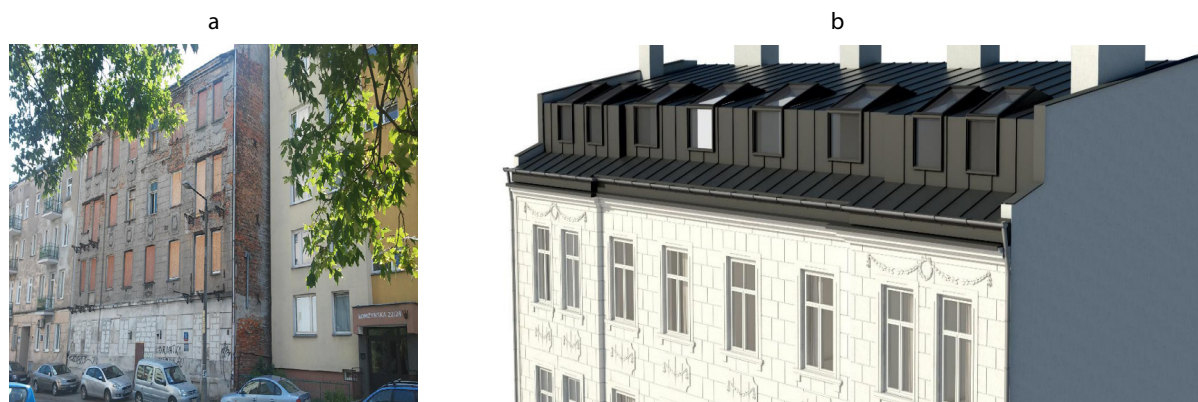
Fig. 7. Tenement house at Łomżyńska 26 in Warsaw – roof geometry before modernisation (a) and after modernisation (reconstruction project: architect Janusz Marchwiński). The shape of the roof, and the withdrawal of the window line, resulted from the street's visual analysis

The possibility of adapting the attic for residential purposes largely depends on the permissible interference in the structure and geometry of the roof and the requirement to preserve the original structural and finishing elements. Most often, the conditions for introducing a new utility function to the space of the attic are maintaining the current height of the crowning cornice in relation to the street level and the existing slope of the visible roof slope (it is possible to change the shape of the roof, e.g., viewpoint). The building where the newly built fragment of the roof has been moved back so that it is not visible from the street is a tenement house at Łomżyńska 26 in Warsaw (Bojarowicz & Żaboklicki, 2016; Fig. 7).

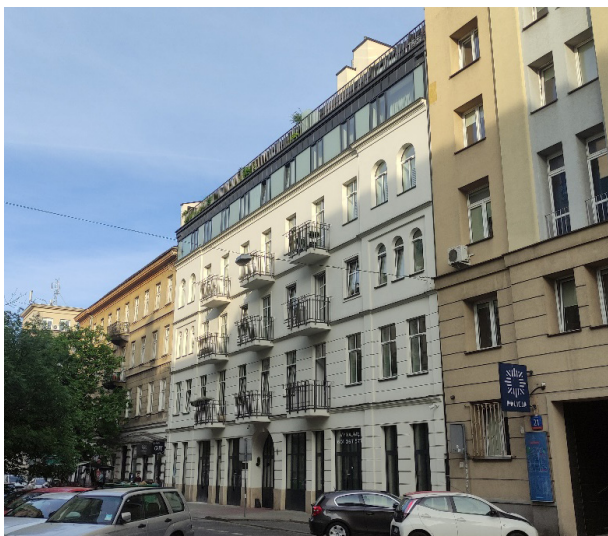
Fig. 9. The front elevation of the superstructured tenement house at Wilcza 19 in Warsaw in 2023. The façade in the strip of the top floor is stylistically different

Harmonisation of the existing façade with the added volume is possible by withdrawing the new storeys, their contrasting aesthetics or continuing the style of the tenement house façade while simplifying and transforming it (Fig. 9).

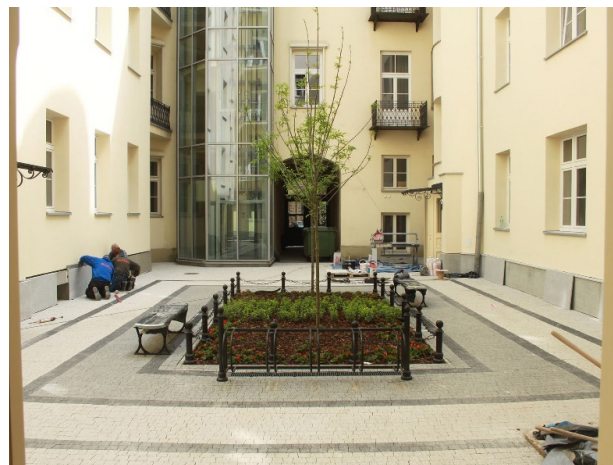
Fig. 10. Renovated courtyard at Wilcza 22 in Warsaw in 2023. The courtyard has been tidied up, and a decorative floor has been introduced to emphasise the shape of the interior, small architectural objects and plants

The most common transformation of the yard space is to organise it by laying a new floor, introducing greenery (Bogdanowski, 1982; Fig. 10) or creating a playground. Spatial changes to the courtyard are limited due to its dimensions and original development.
